*U.S. Department of Energy
Office of Legacy Management*

2006 Annual Site Inspection and Monitoring Report for Uranium Mill Tailings Radiation Control Act Title I Disposal Sites

December 2006

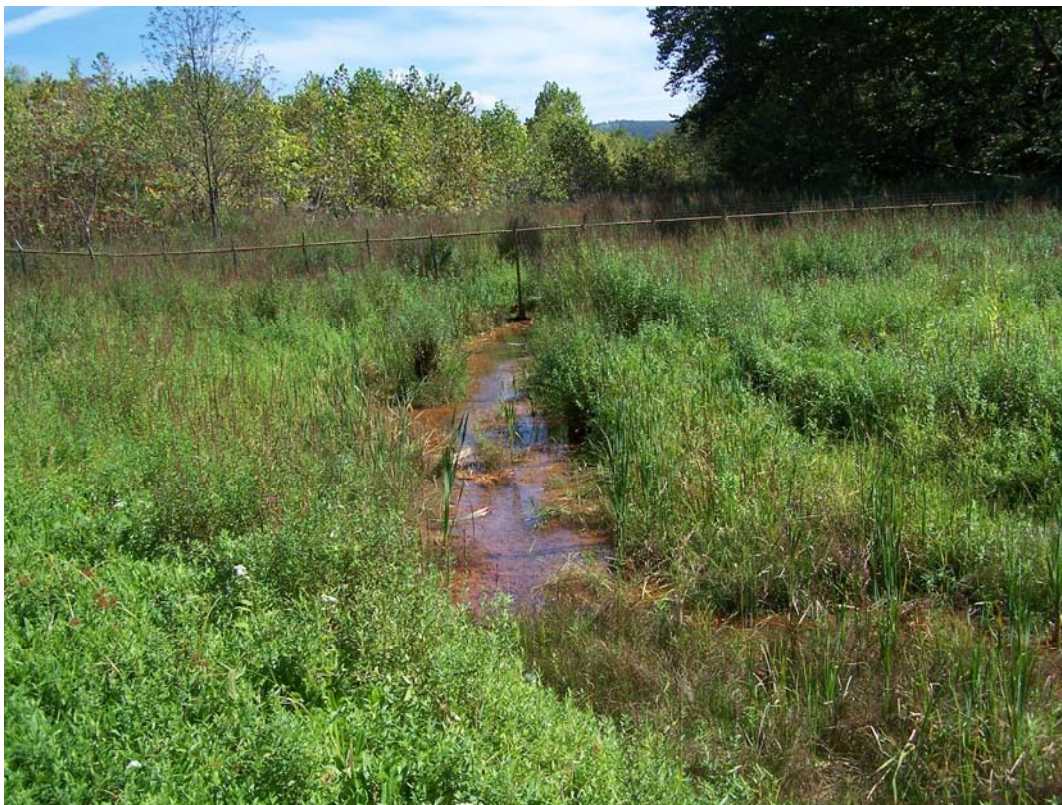
BUR 9/2006. PL-3. Slough and west fence line.

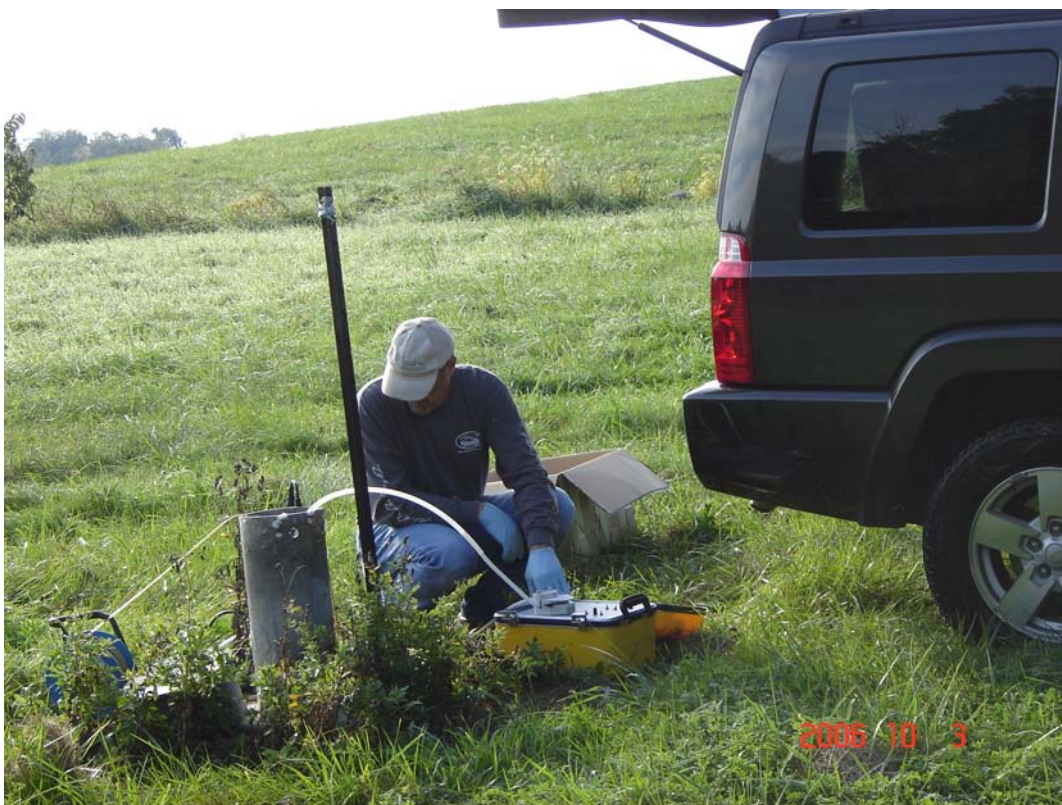
CAN 9/2006. PL-4. Ground water sampling.

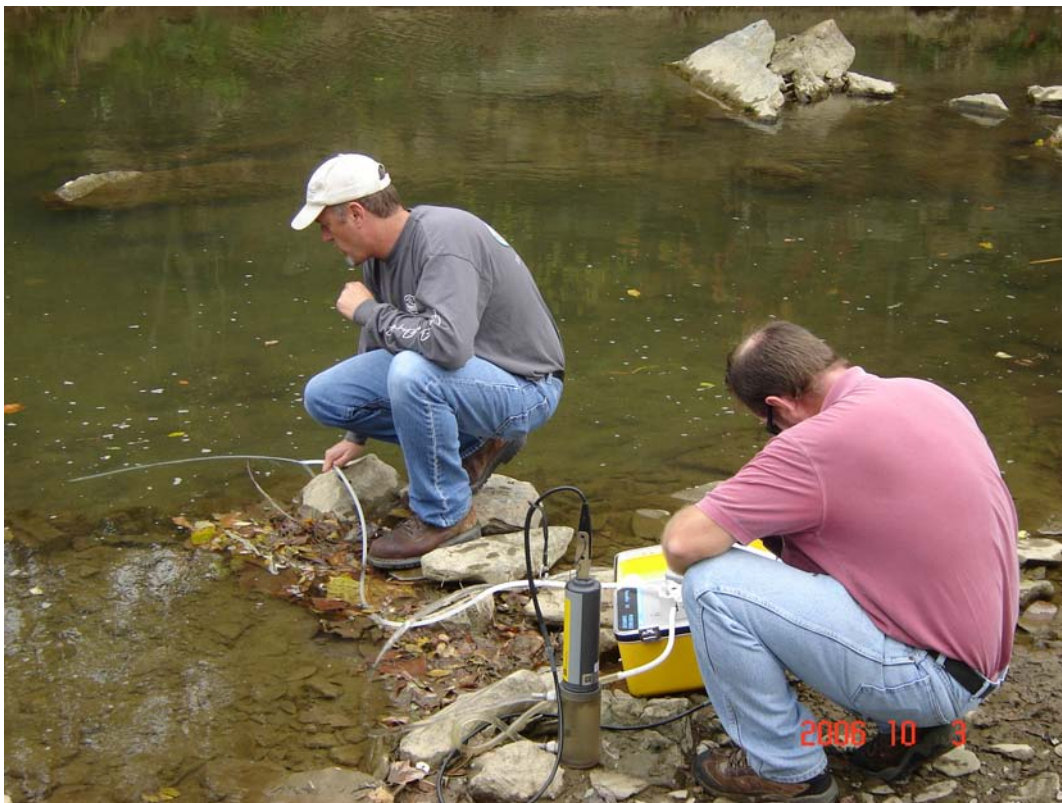
CAN 9/2006. PL-5. Surface water sampling.

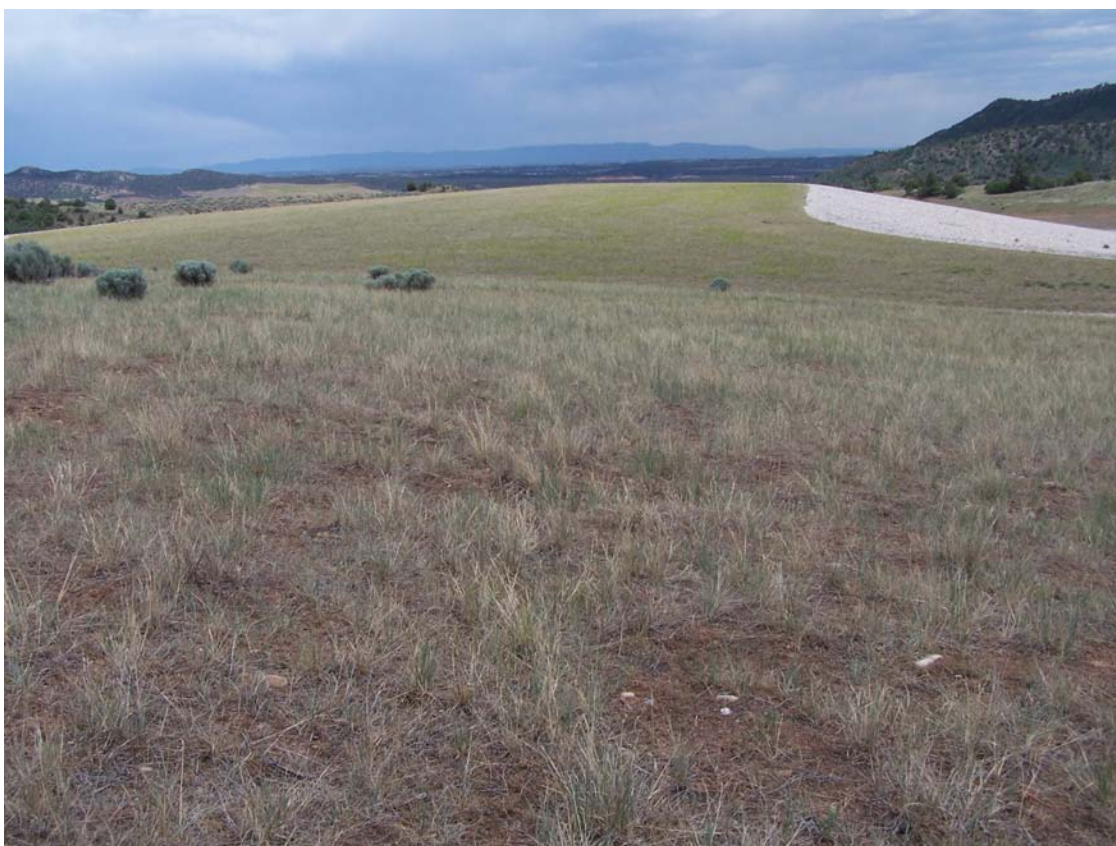
DUR 6/2006. PL-1. Disposal cell top.

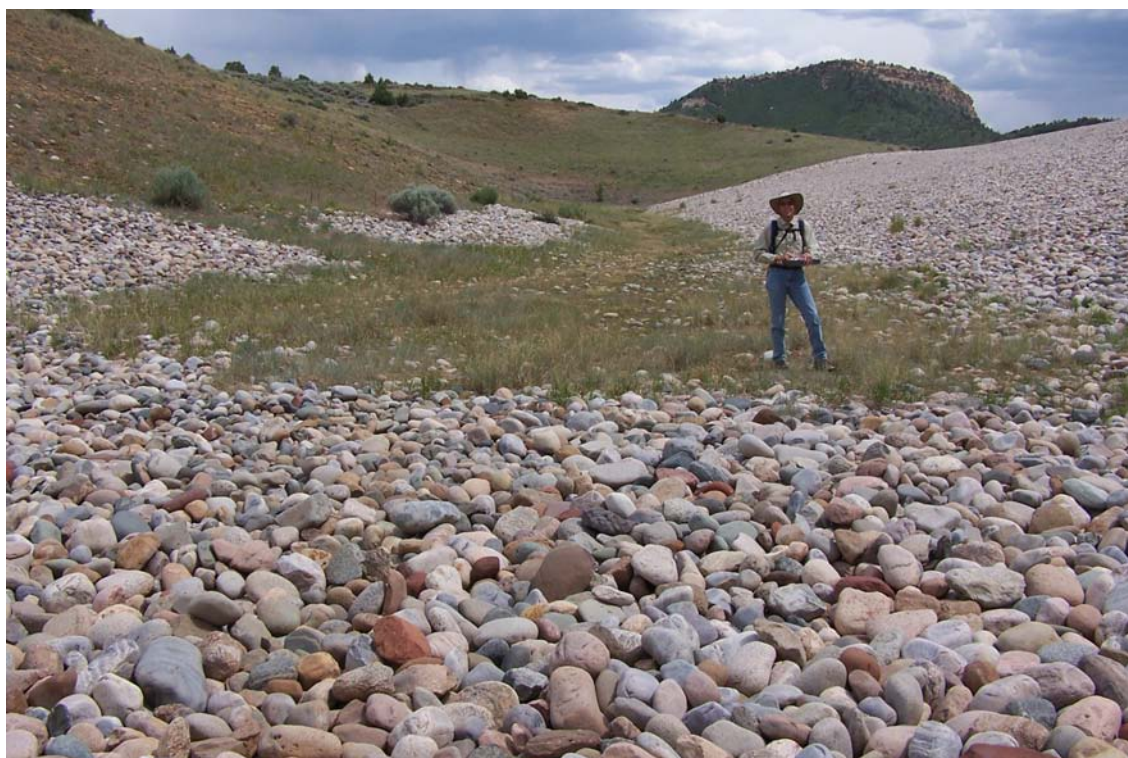
Photograph Location Number	Azimuth	Description
PL–1	95	Disposal cell top.
PL–2	150	Sediment deposition in Diversion Channel No. 1.
PL–3	330	Northeast Outflow; no new erosion.
PL–4	20	Fresh headcuts in gullies in the southwest portion of the site.

DUR 6/2006. PL-2. Sediment deposition in Diversion Channel No. 1.

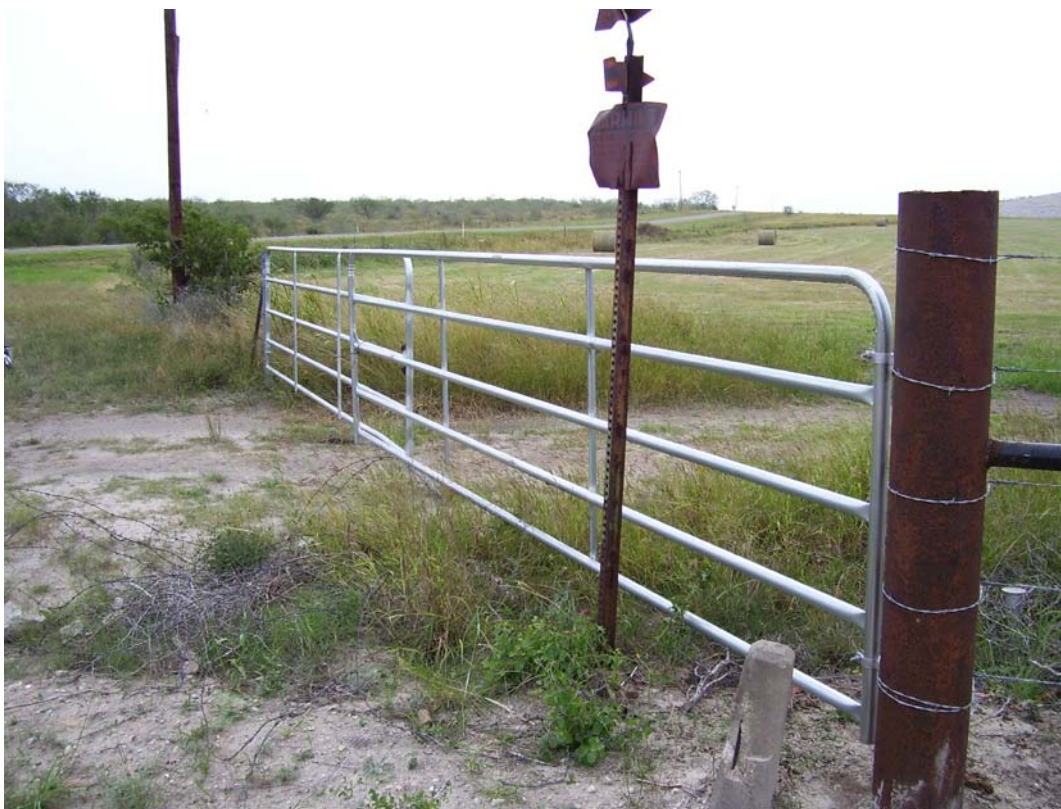
FCT 1/2006. PL-1. New vehicle gate, north corner of the site.

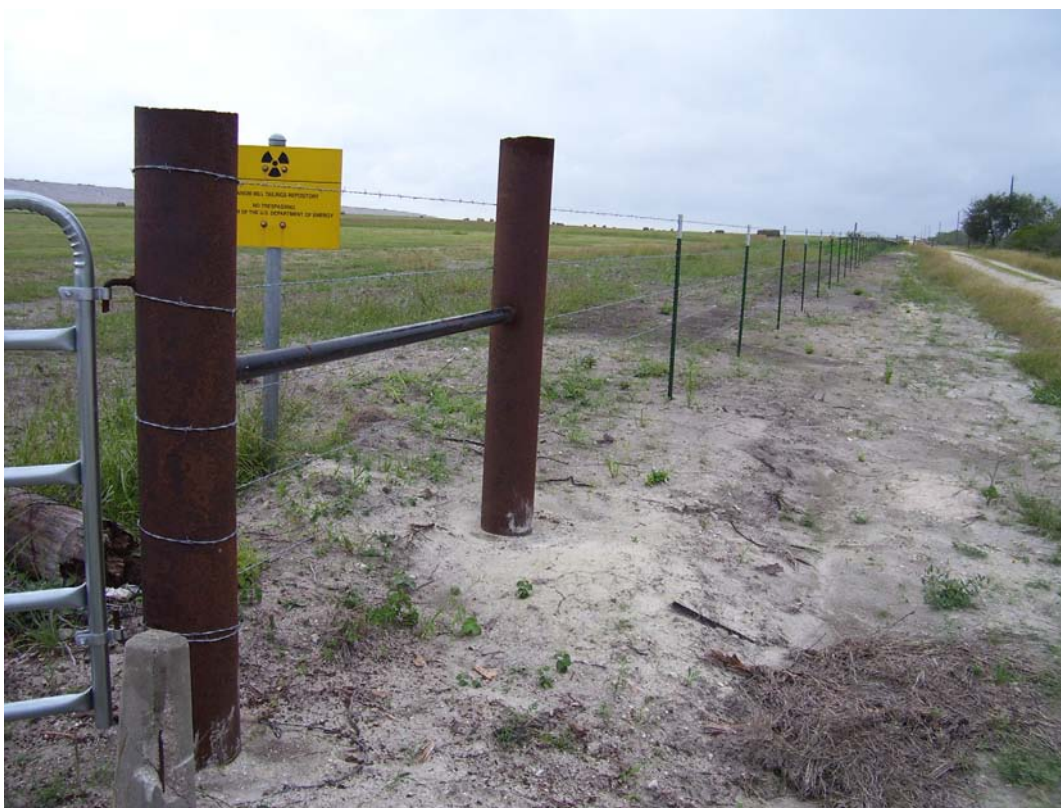
FCT 1/2006. PL-2. New perimeter fence on northwest property boundary.

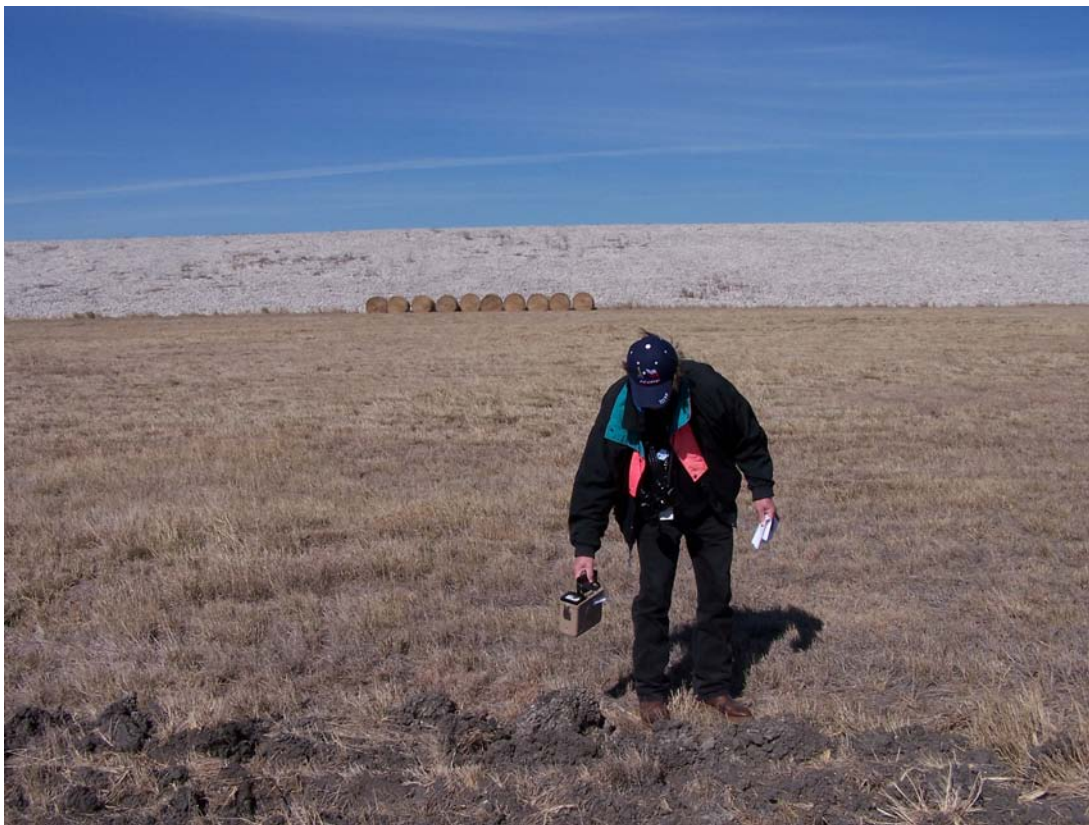
FCT 1/2006. PL-6. State of Texas inspector collecting gamma exposure rates.

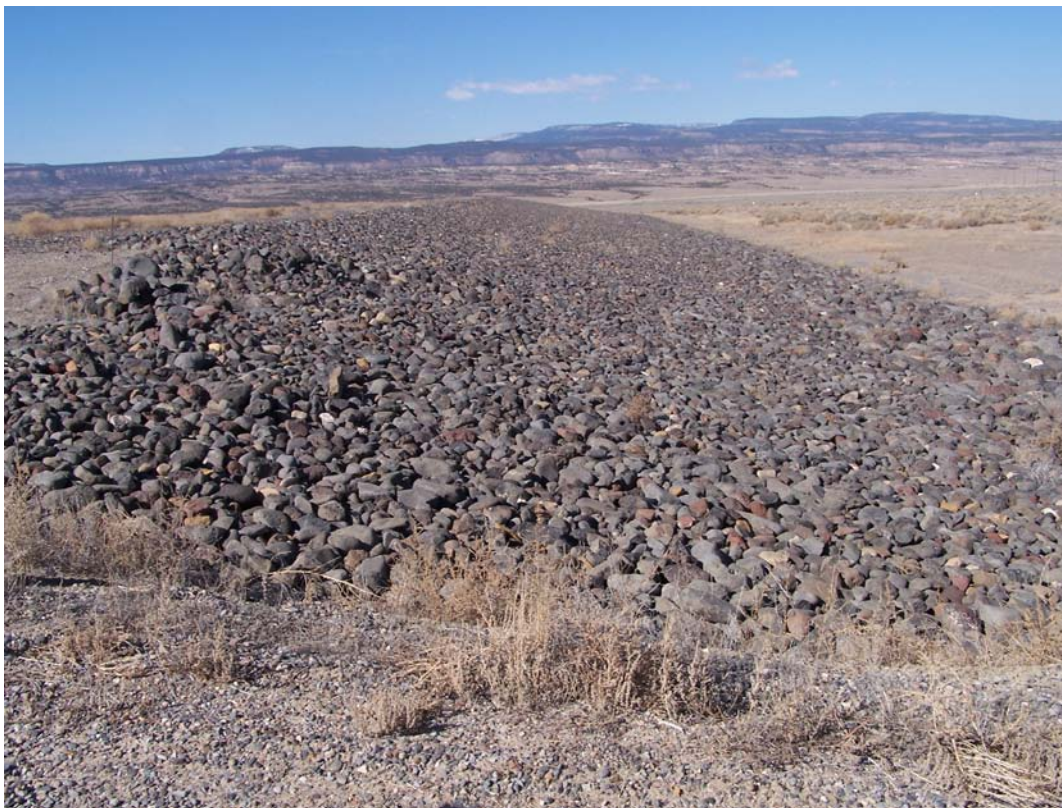
Closed Portion of the Disposal Cell—The top and side slopes of the disposal cell are covered with basalt riprap. The rock is durable and was in excellent condition. There was no evidence of slope instability and only minor plant encroachment occurring on the side slopes (PL-1).

GRJ 3/2006. PL-1. North side slope of the disposal cell.

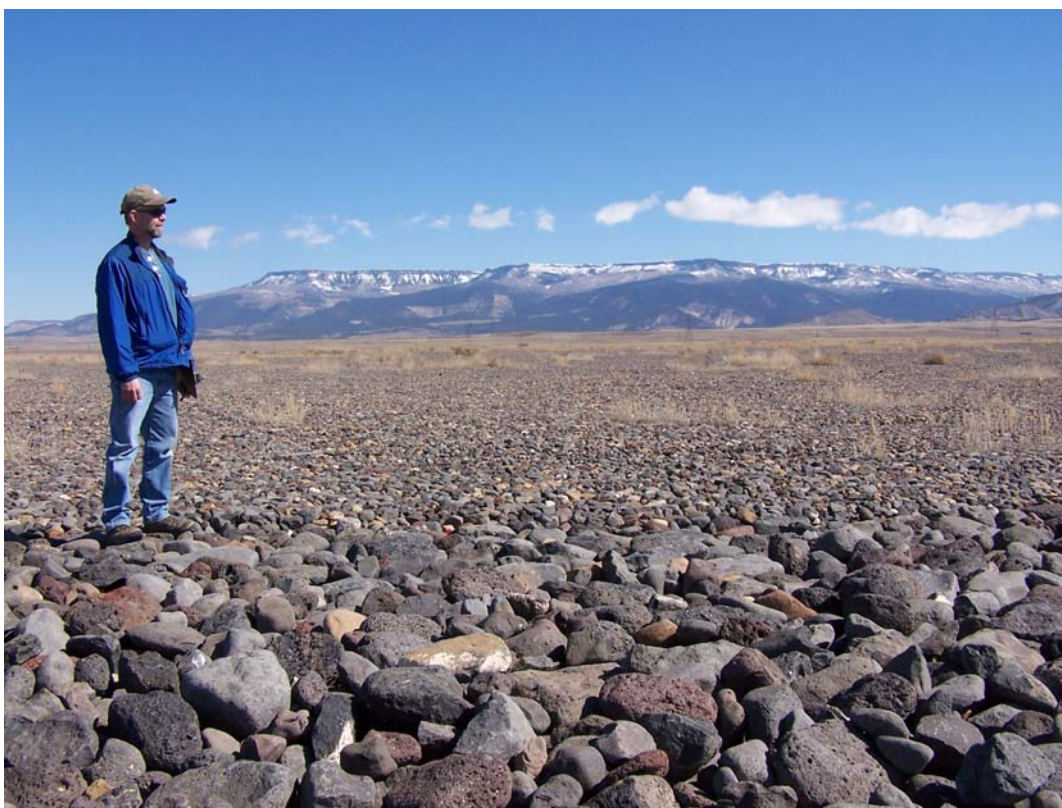
Annual grasses and weeds grow on most of the cell cover (PL-2), and scattered deep-rooted shrubs (primarily four-winged saltbush and rabbitbrush) have been persistent on the cover. The annual grasses and weeds have shallow root systems and do not degrade cell cover performance. As stated in the LTSP, however, the deep-rooted shrubs potentially could pose a threat to the

GRJ 3/2006. PL-2. Cell top viewed from the southwest corner of the disposal cell.

- 6B long-term integrity of the radon barrier and are required to be removed. All the deep-rooted shrubs that were found were cut and their stems were sprayed with herbicide. A preliminary study of the in situ saturated conductivity of the cover materials was conducted at four test locations in 2003 to see if the root systems of four-winged saltbush shrubs increased infiltration through the radon barrier. The results were not definitive and a follow-up investigation of the cover materials may be desirable to determine whether the deep-rooted shrubs need to be removed periodically or if leaving them in place would not change (or would improve) the function of the radon barrier in preventing infiltration of water into and the release of radon gas from the encapsulated materials. Vegetation growth on the cell also would likely provide additional erosion protection. However, unless it is determined that the shrubs can remain, they will be periodically removed.

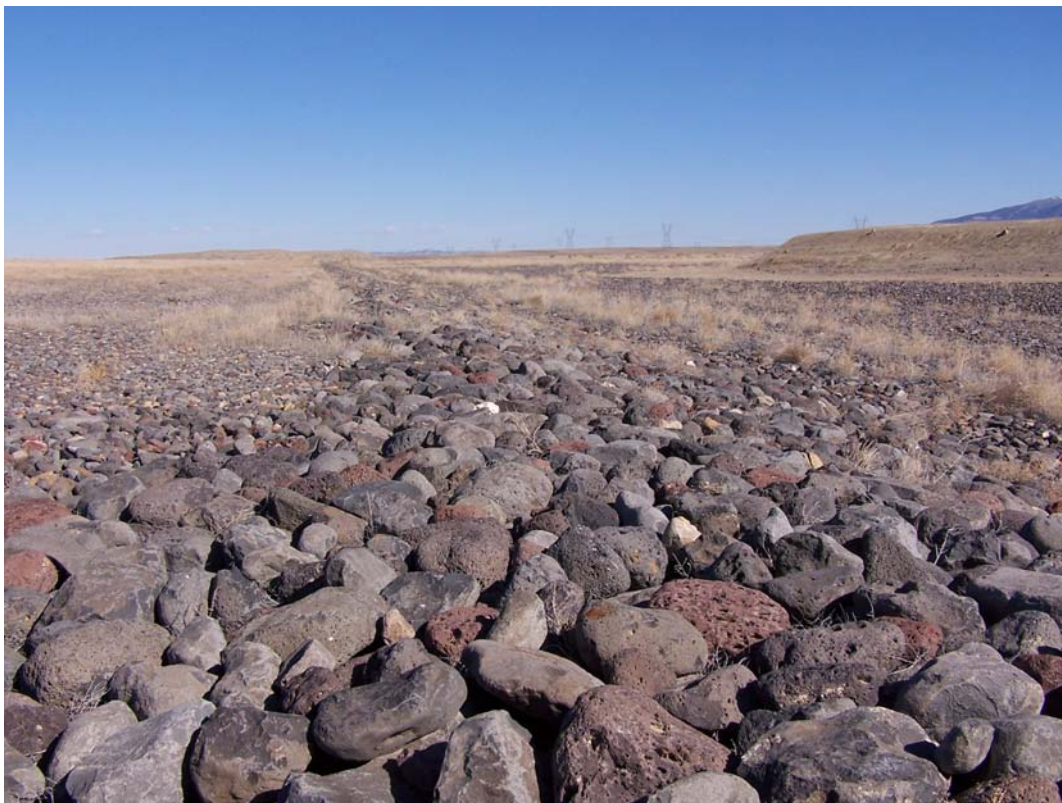
GRJ 3/2006. PL-3. South diversion channel viewed from the southeast corner of the disposal cell.

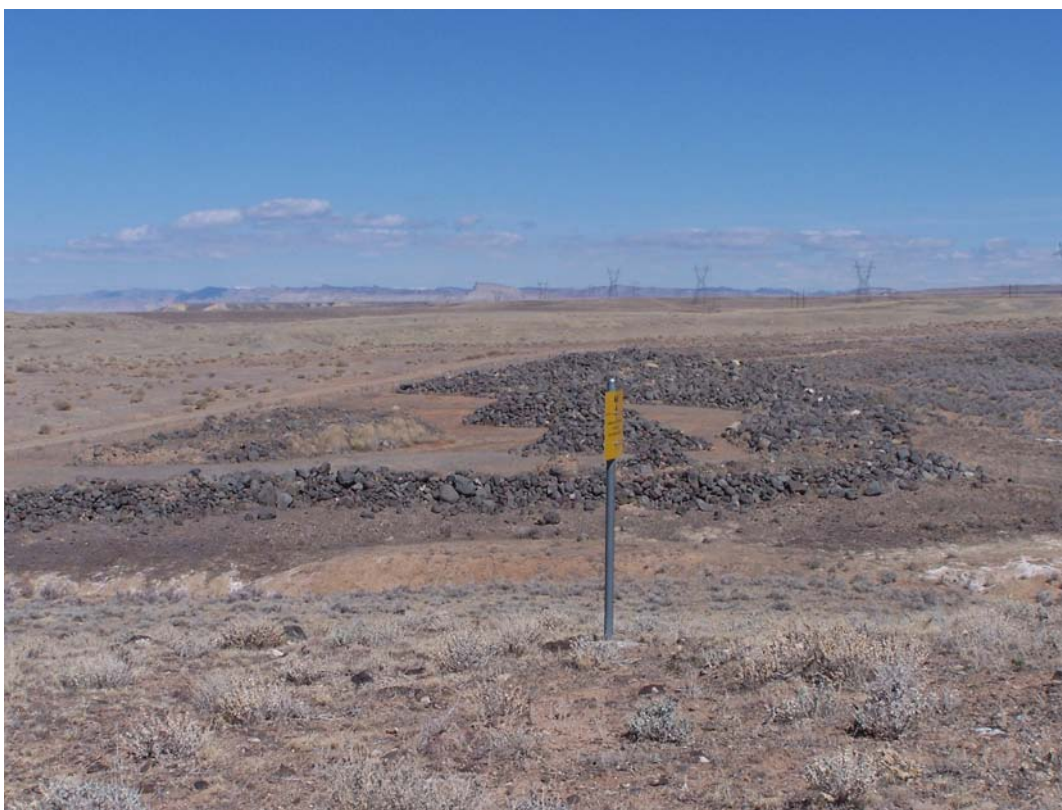
GRJ 3/2006. PL-4. Riprap stockpile area near the southeast corner of the disposal site.

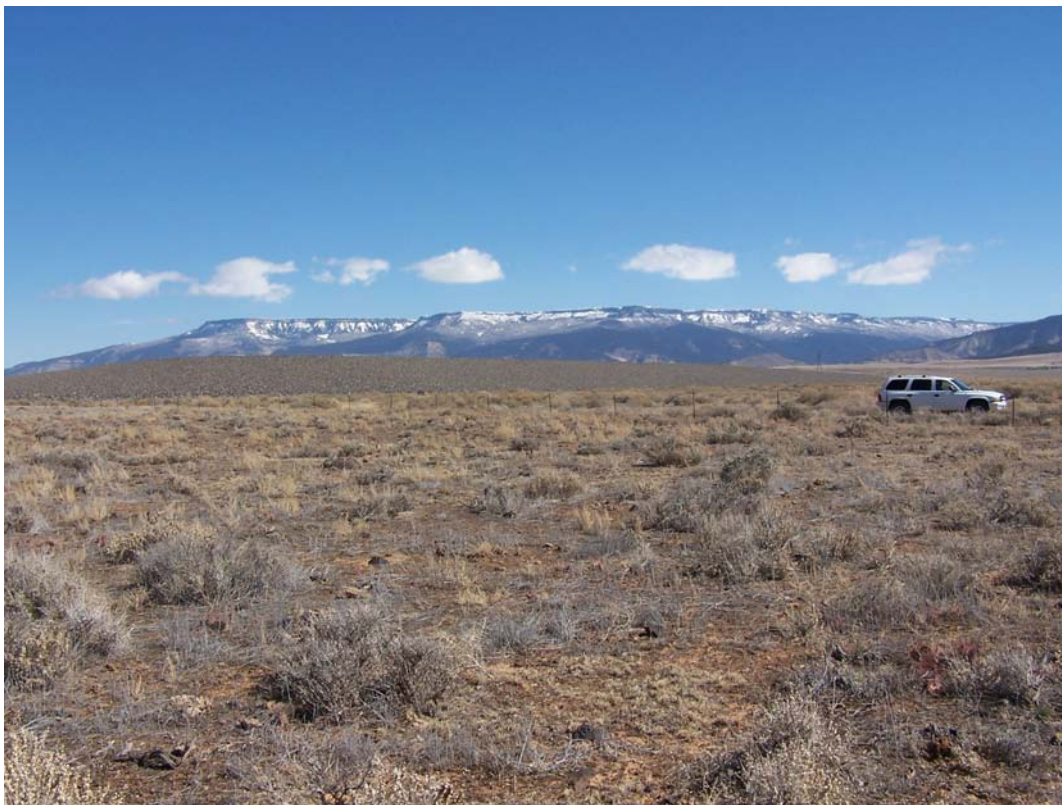
On the south and west sides of the disposal site, between the disposal cell and the perimeter fence, the ground is relatively flat and covered with native vegetation that consists primarily of perennial grasses and small shrubs (PL-5). Unlike the areas north and east of the disposal cell, the areas south and west are mostly undisturbed. No erosion was observed south and west of the disposal cell within the site. A small erosional area was present along the site boundary between the perimeter fence and a wash near the south diversion channel outfall. The gullies in this area were found to be self-armoring with basaltic rock and appeared to be stable.

GRJ 3/2006. PL-5. Disposal cell viewed from the southwest corner of the disposal site.

6D Tamarisk is a deep-rooted, water-depleting noxious weed that is recommended for removal in Mesa County. Isolated stands of tamarisk were found growing along the south side and northwest corner of the site and were removed. Although the plants do not threaten the integrity or performance of the disposal cell, they were cut and treated with herbicide to remove the seed source to reduce the chance of the plants from spreading and establishing on the disposal cell.

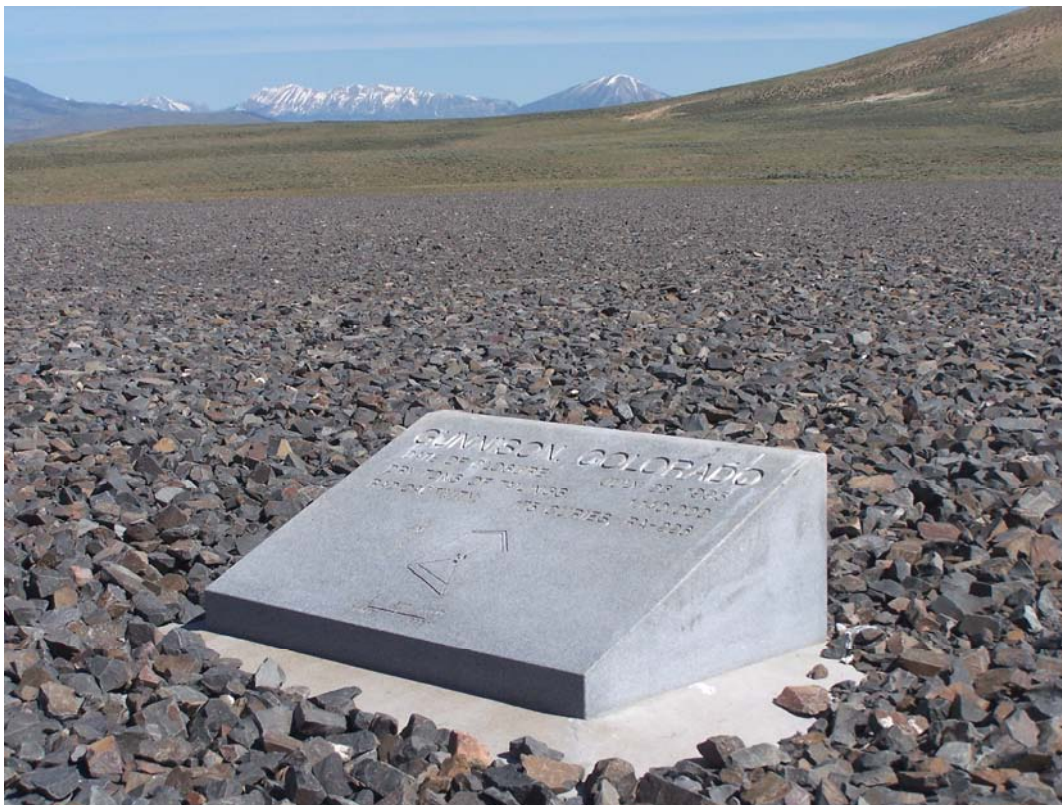
GUN 5/2006. PL-1. Site marker SMK-2.

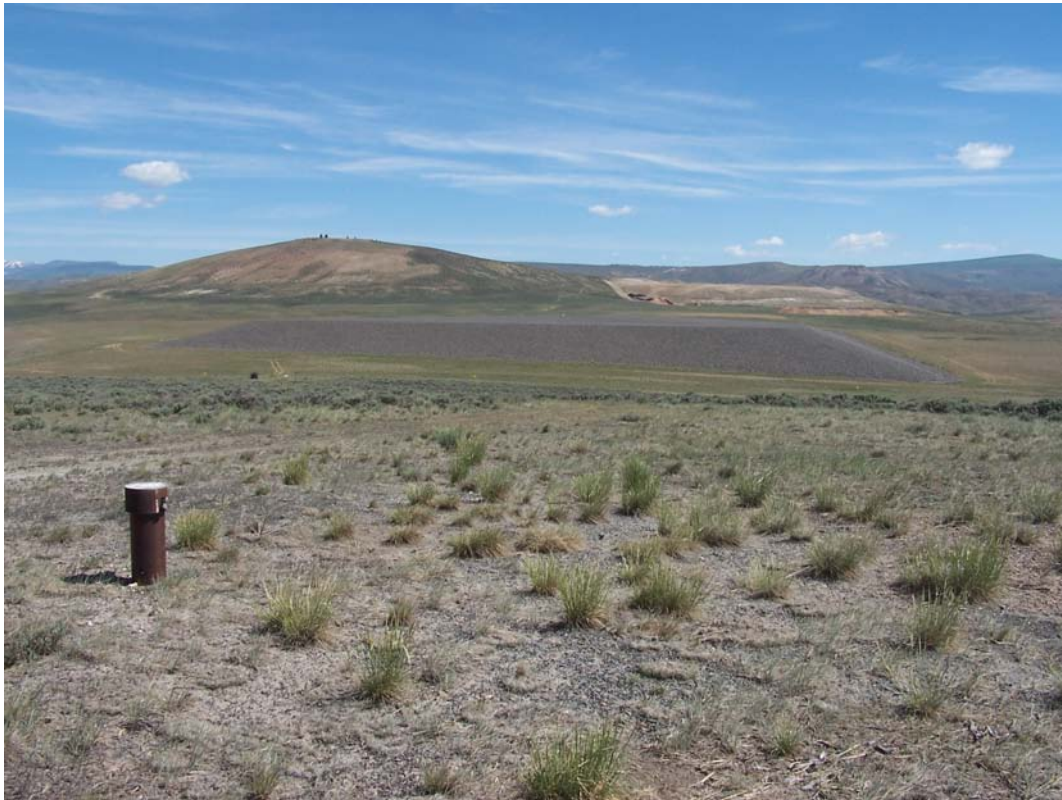
GUN 5/2006. PL-2. Disposal cell viewed from monitor well MW-0710.

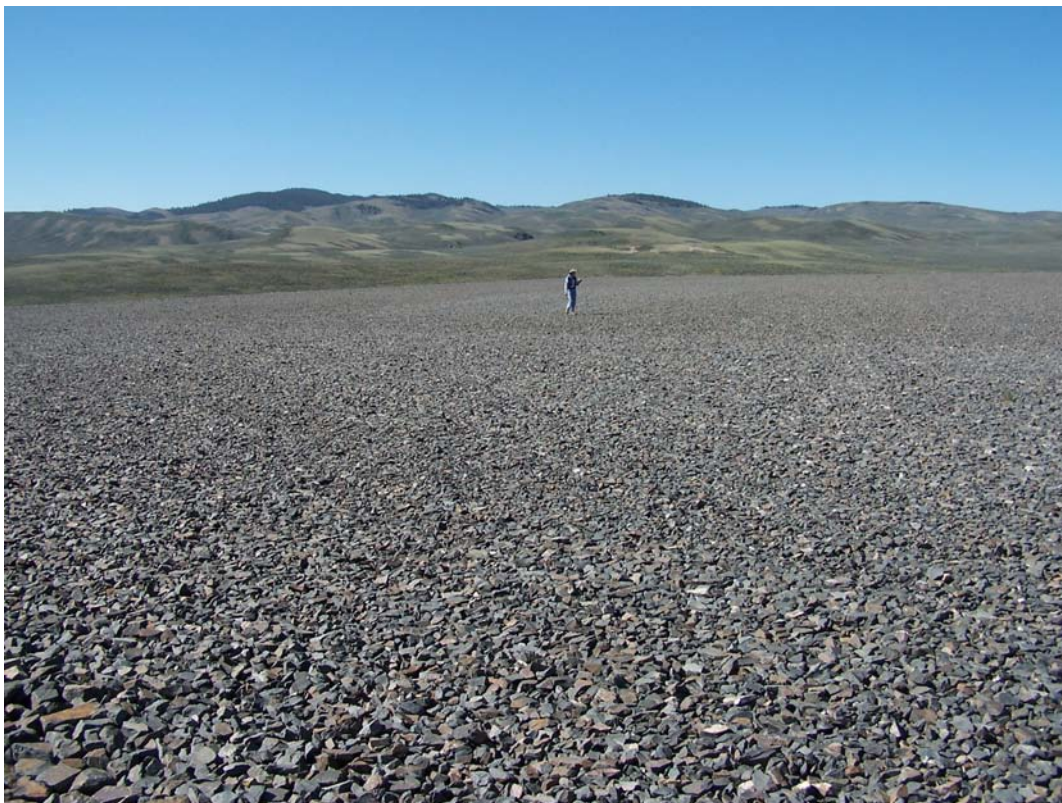
Top of Disposal Cell—The top of the disposal cell was in excellent condition (PL-3). There was no evidence of erosion, settling, slumping, or rock degradation. Several isolated patches of grass were observed on the disposal cell cover; however, these shallow-rooted plants do not impact the performance of the cover. Many small indentations were present on the cell cover. The indentations, with dimensions up to 4 inches across and up to 4 inches deep, appear to have been caused by pronghorn antelope. None of the indentations penetrate into the bedding layer under the rock cover and are not a cause for concern.

GUN 5/2006. PL-3. View south across of the disposal cell top.

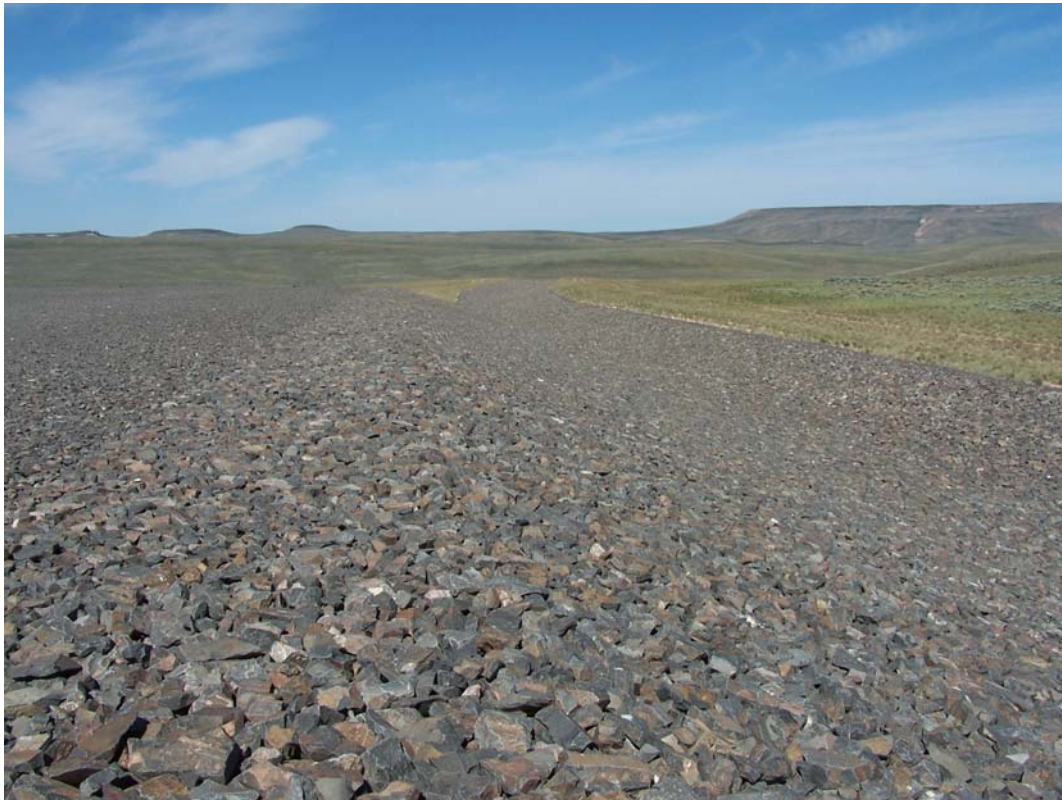
Side Slopes, Apron, and Diversion Ditches—The riprap-covered side slopes, apron, and diversion ditches were in excellent condition (PL-4). No evidence of slumping, settling, or significant encroachment of vegetation was observed.

GUN 5/2006. PL-4. View west of the north side slope, apron, and diversion ditch.

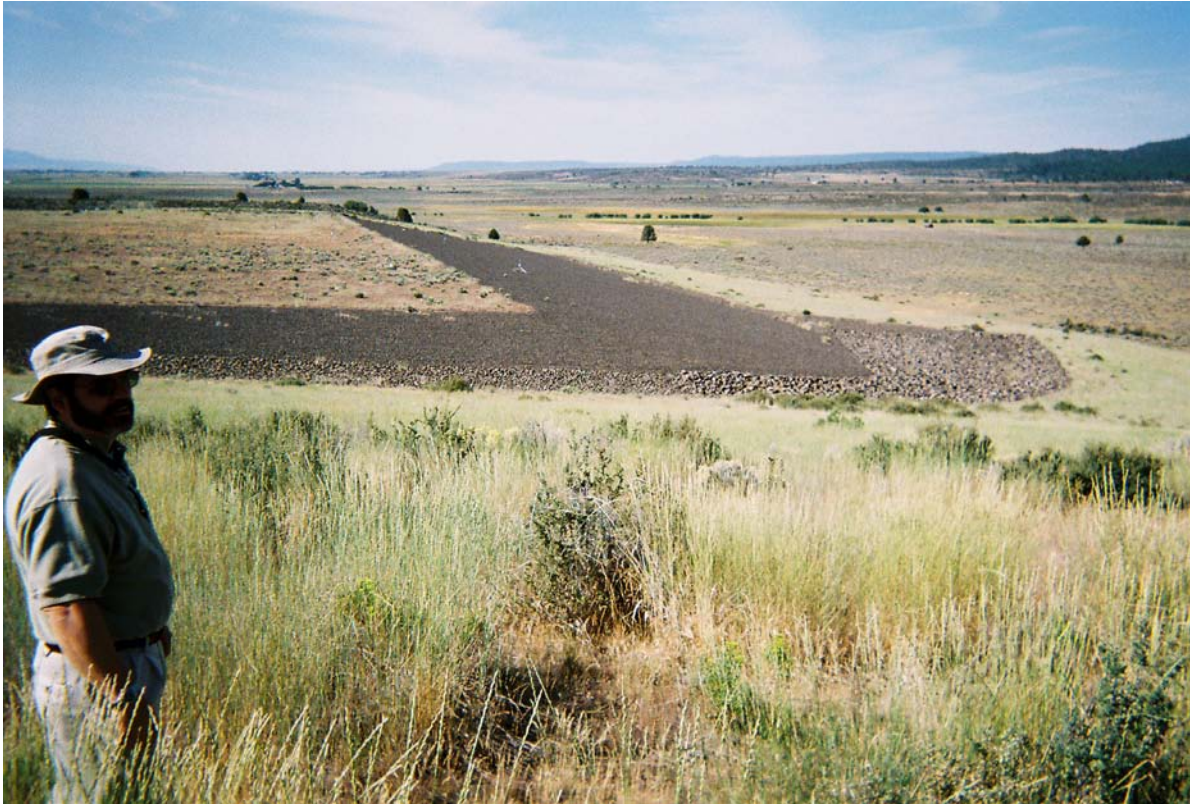
LKV 7/2006. PL-1. Disposal cell (background – upper left) showing vegetative cover on the cell top.

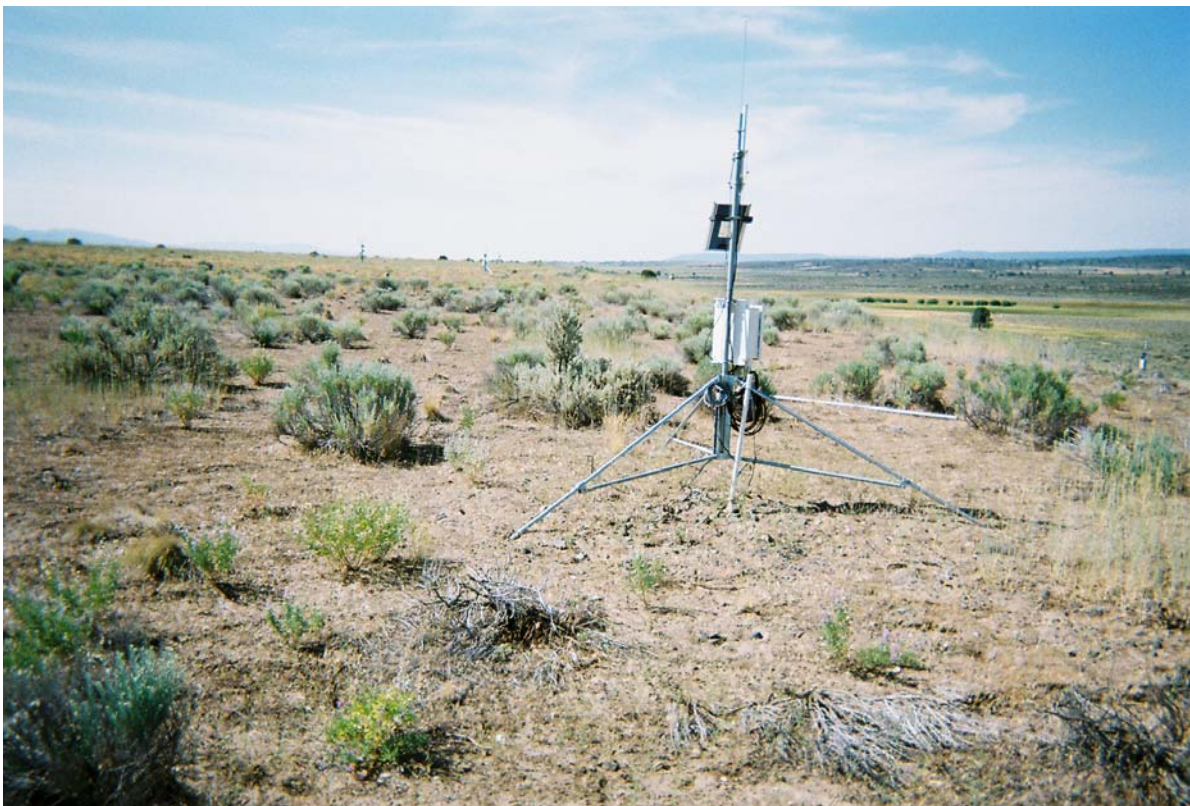
LKV 7/2006. PL-2. Fluxmeters and weather station on the disposal cell top.

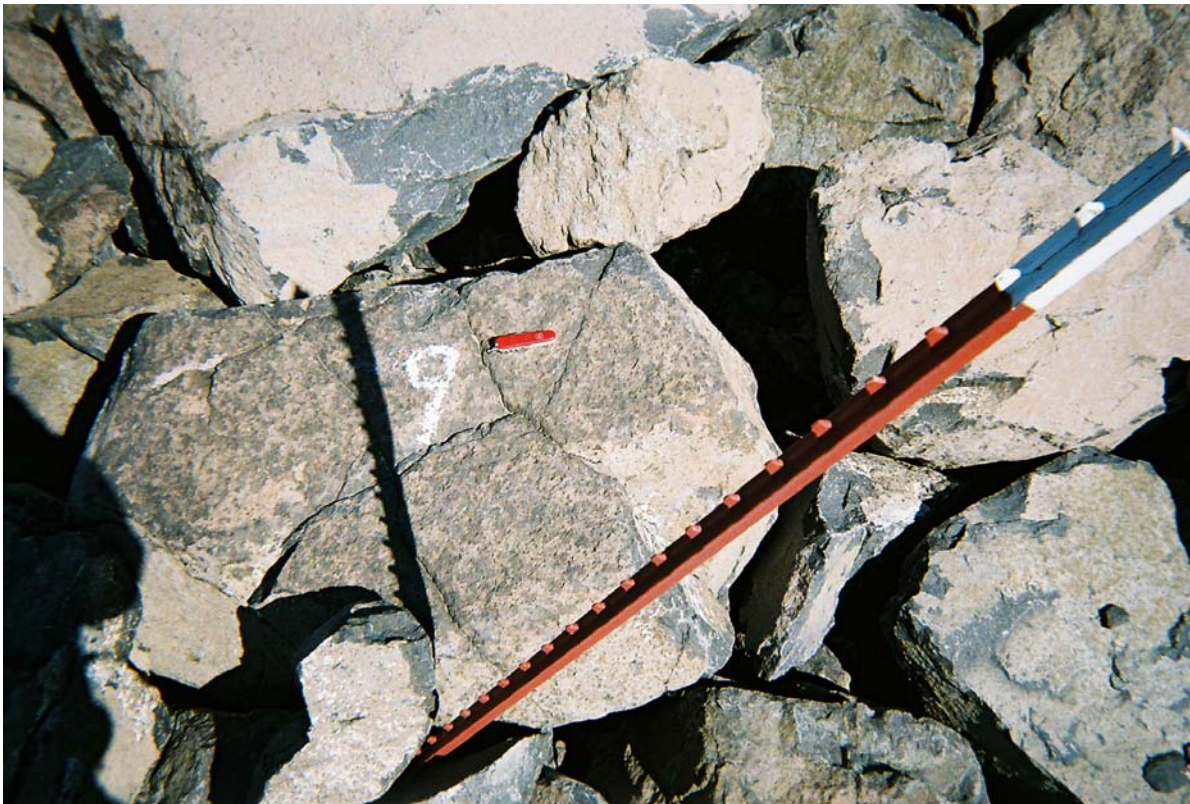
LKV 7/2006. PL-4. Riprap monitoring location 9 at the energy dissipation area.

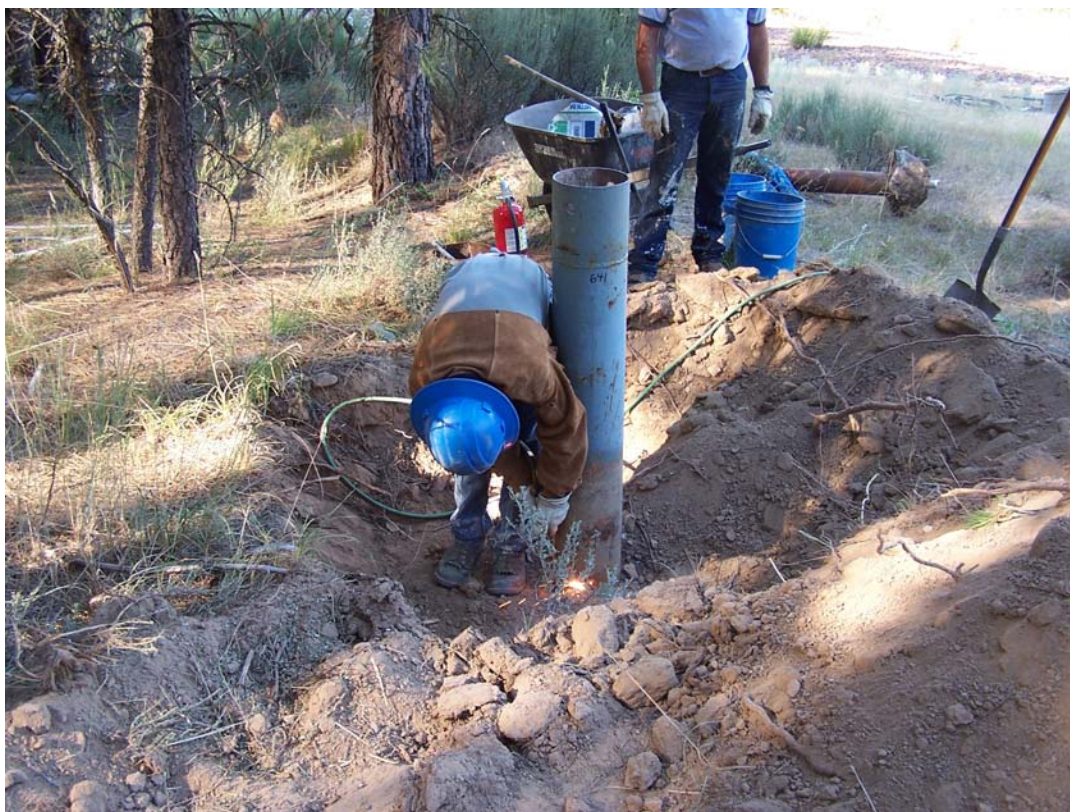
LOW 7/2006. PL-3. Cutting the surface casing of monitor well MW-0641.

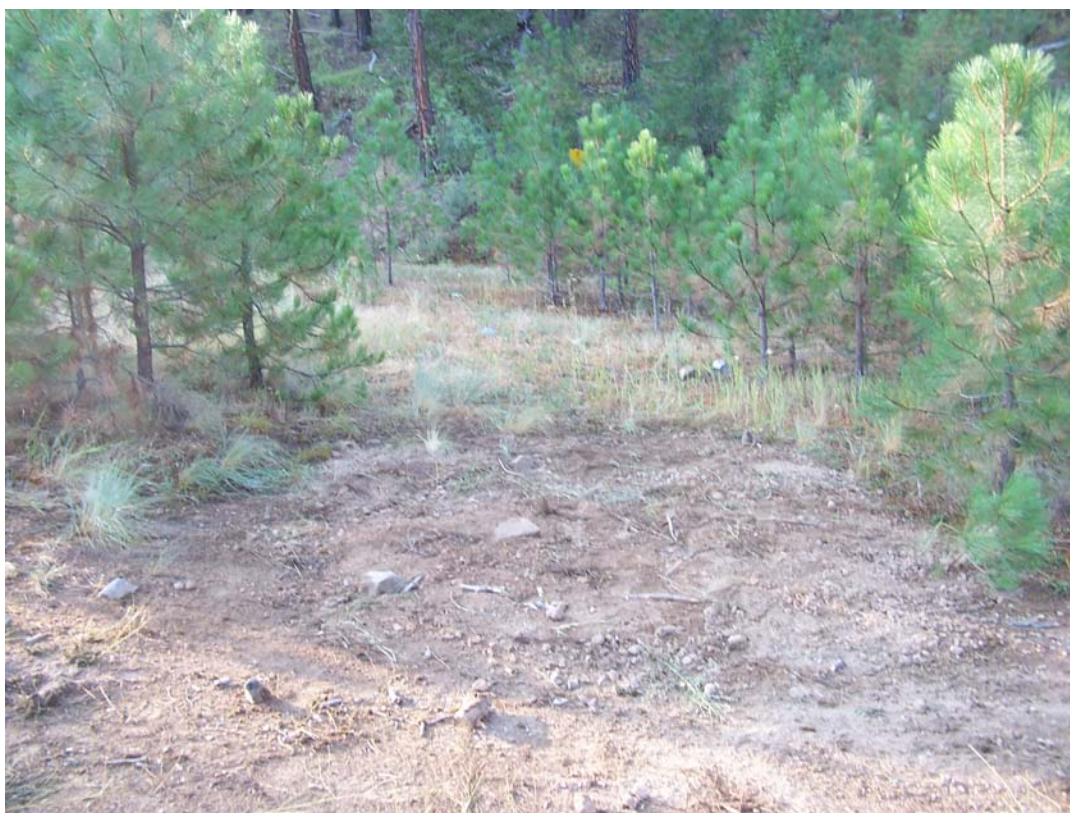
LOW 7/2006. PL-4. Reclaimed location of decommissioned monitor well MW-0580.

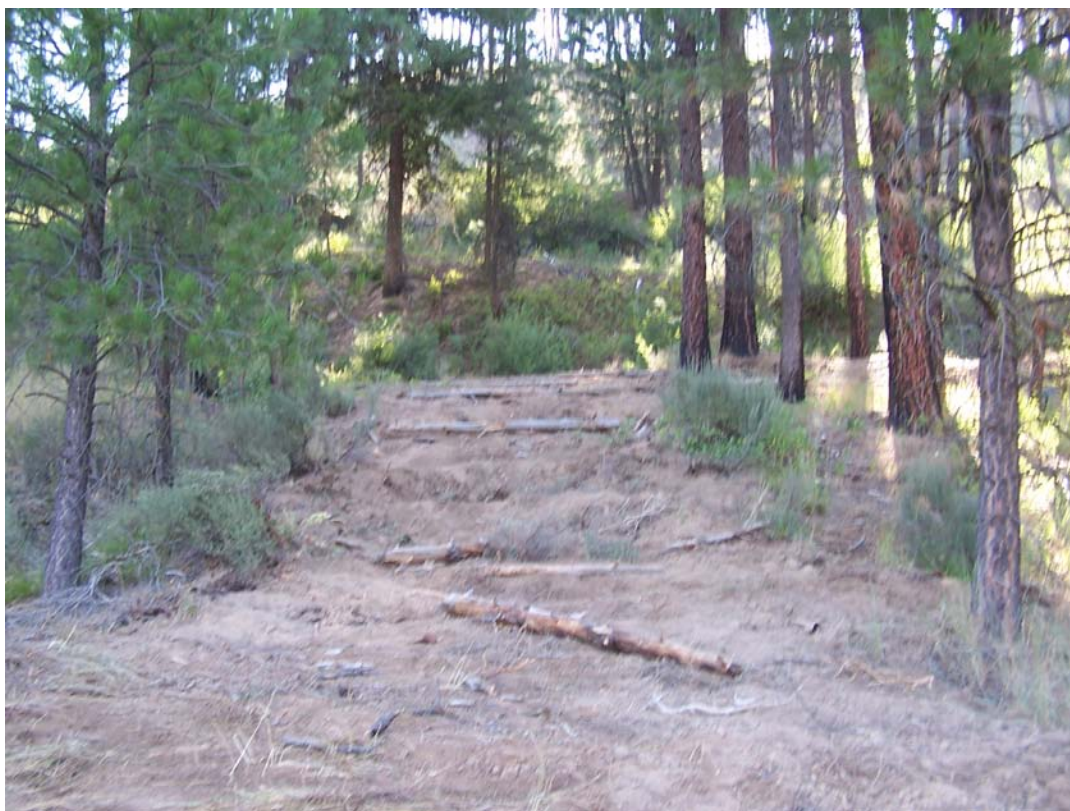
LOW 7/2006. PL-8. Reclaimed portion of access road to decommissioned monitor well LOW-01-029.

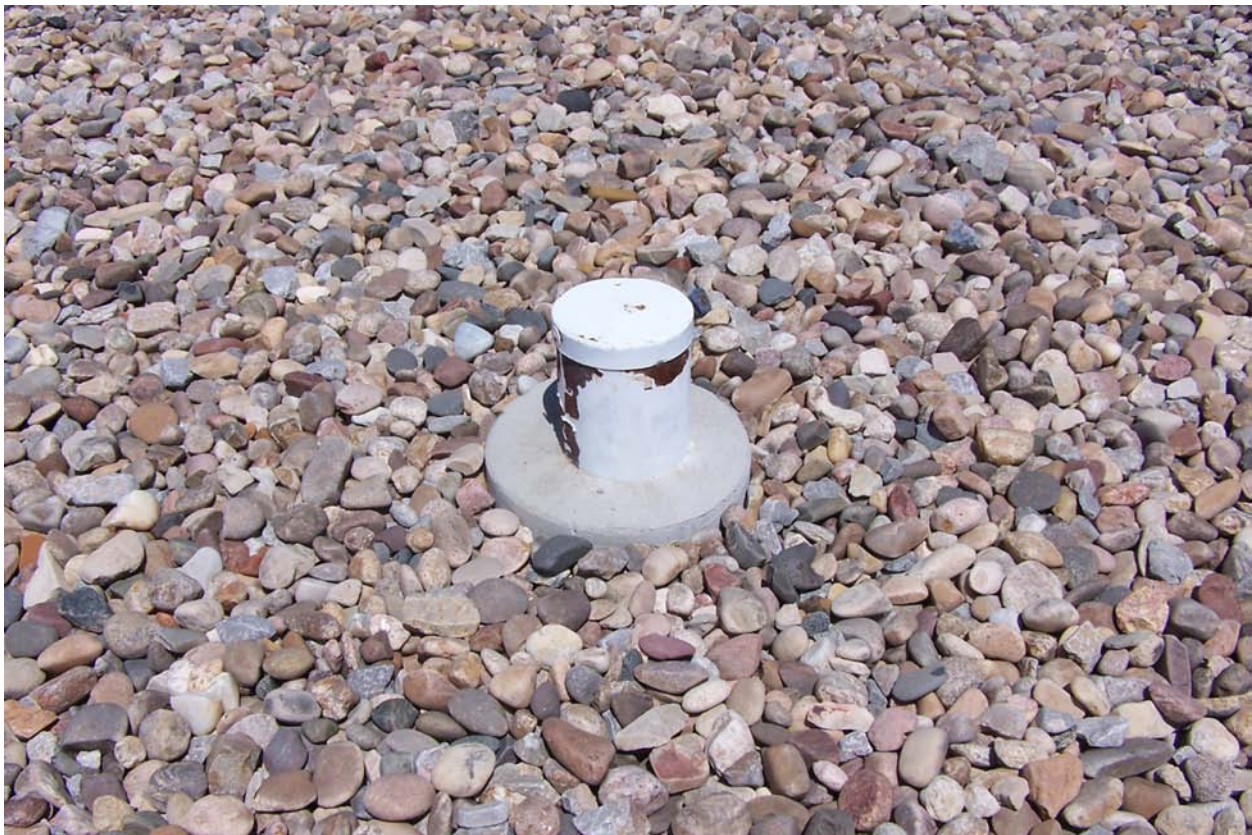
Settlement Plates—There are nine settlement plates on top of the disposal cell (PL-2). All were secure and in good condition. No visual evidence of settlement occurring on the disposal cell cover was observed in 2006.

MAY 8/2006. PL-2. Settlement Plate No. 9.
